HP-8640 Service: Hints & Kinks

Service Hints

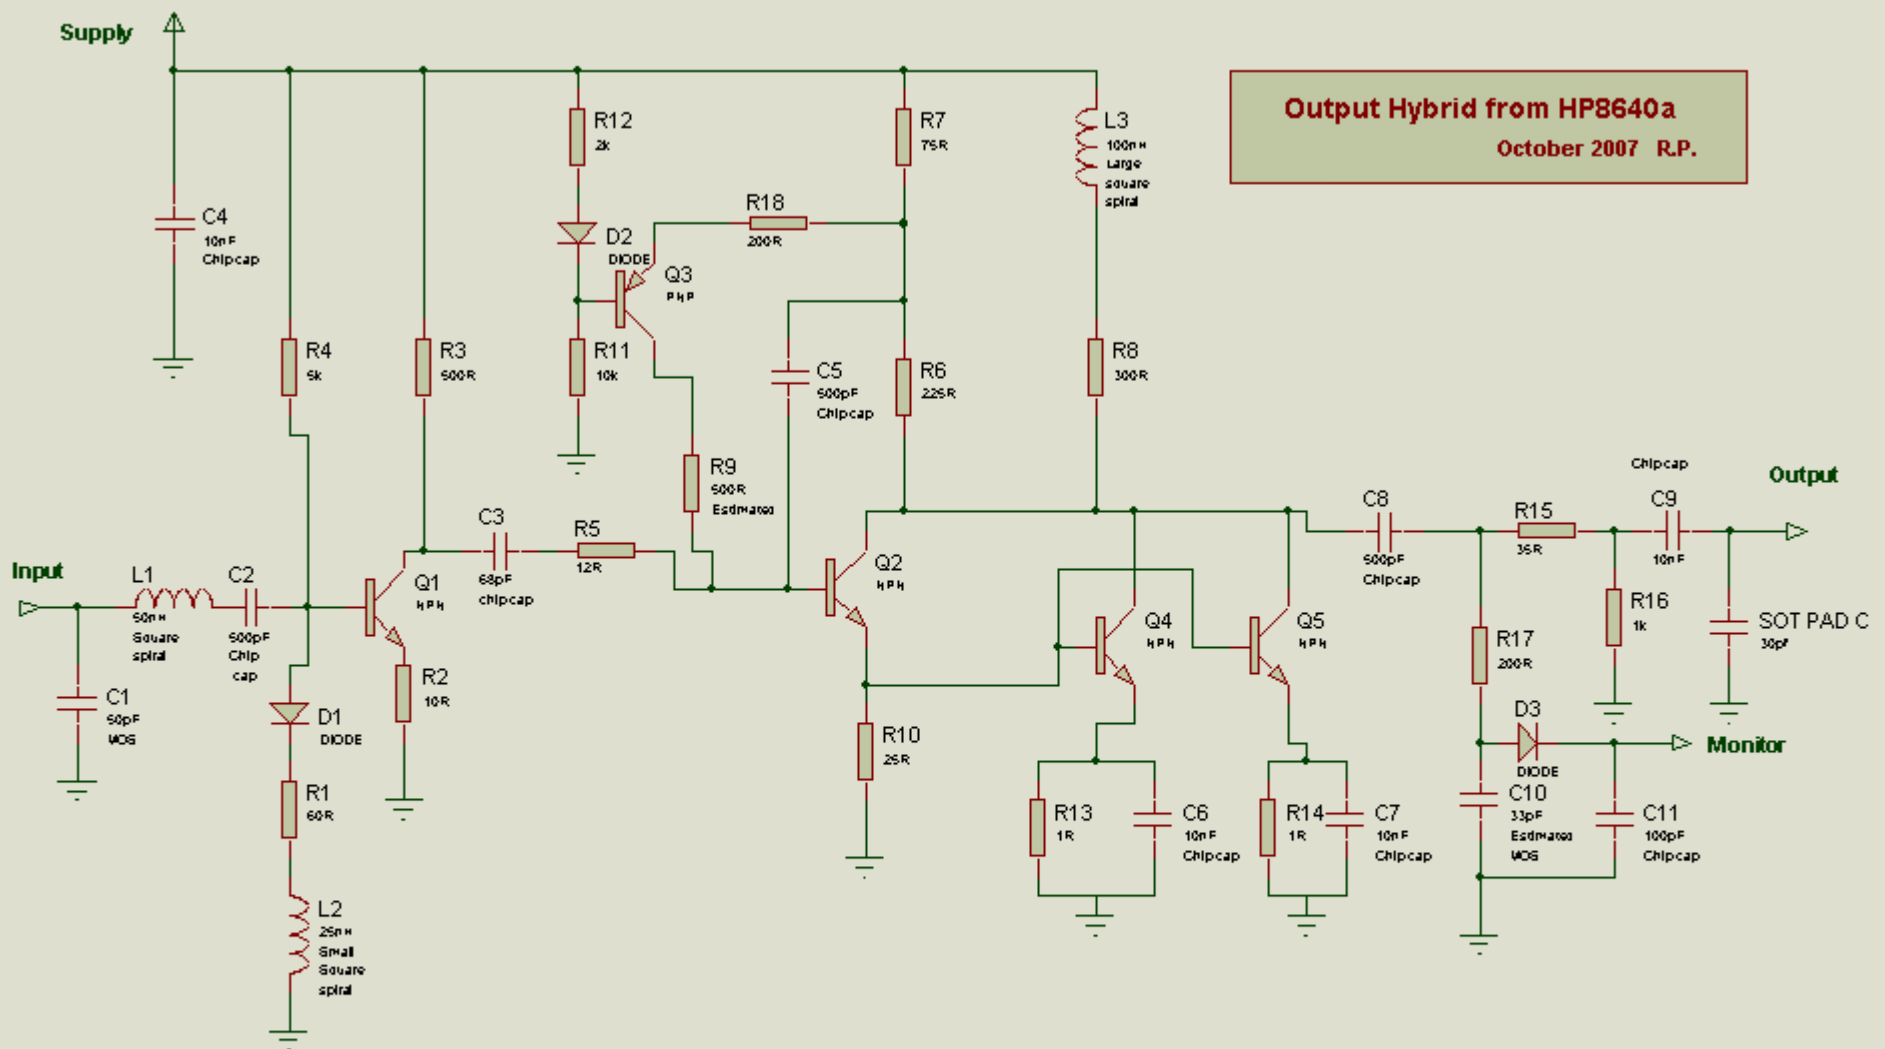
"The schematic attached is an educated guess at the hybrid by looking closely at the blown up photo. The resistor values are scaled by measuring the square area of a couple of known resistor values and applying this to the other resistor tracks. Capacitors are estimated. The inductors are calculated. This excellent job was done by Richard, G3SHK who made this sort of stuff in a past-life at Philips labs".

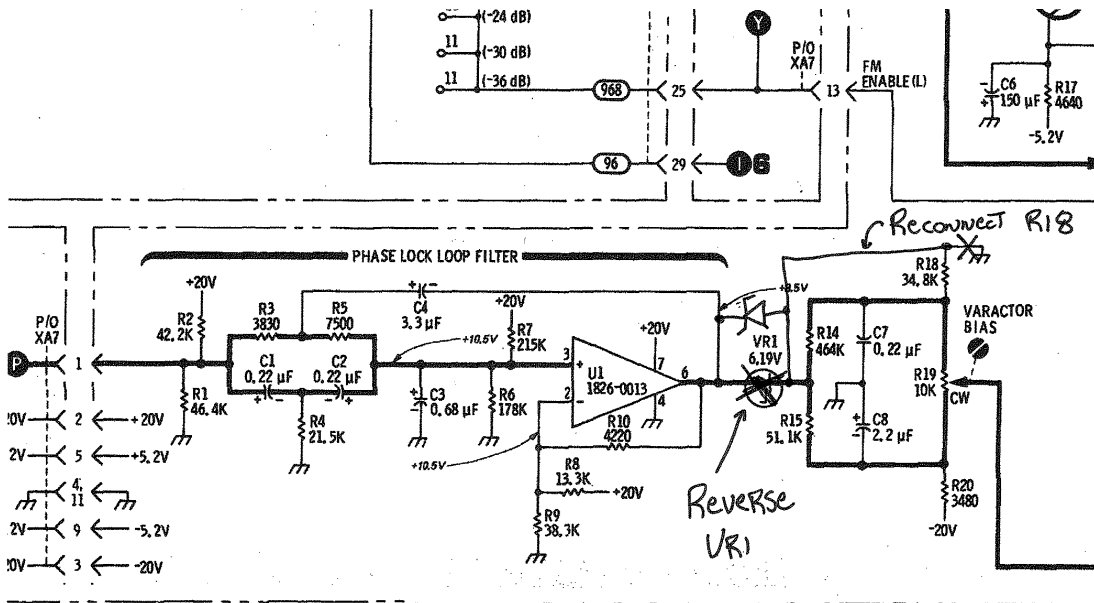
Figure 8-27. FM Shaping Circuits and Phase Lock

PHASE LOCK LOOP FILTER AFTER MODIFICATION

Reverse VR1

Reconnect the ground side of R18 to Anode of VR1 so R18 is in parallel with R34.

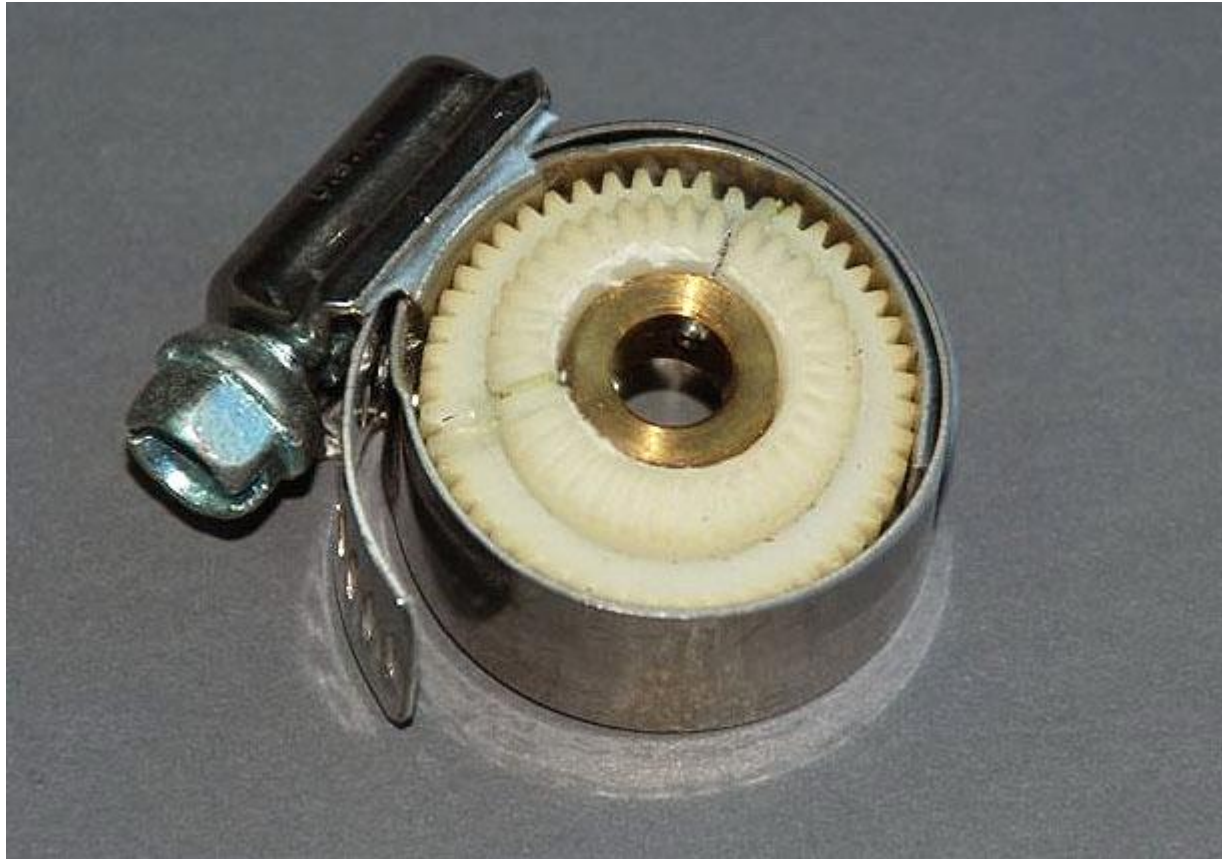
Fig 7. Hose clamp holding gear together while glue sets

I was not able to find any 24 hour epoxy however I did find 5 hours epoxy. In order to hold the gears together while the glue sets I used a hose clamp. Be very careful that you don't tighten the camp too much or you may crush the teeth! Make sure there is no glue between the teeth and the gear is flush with the brass hub.

I recommend that you leave the gears in the clamp for 24 hours before removing them.

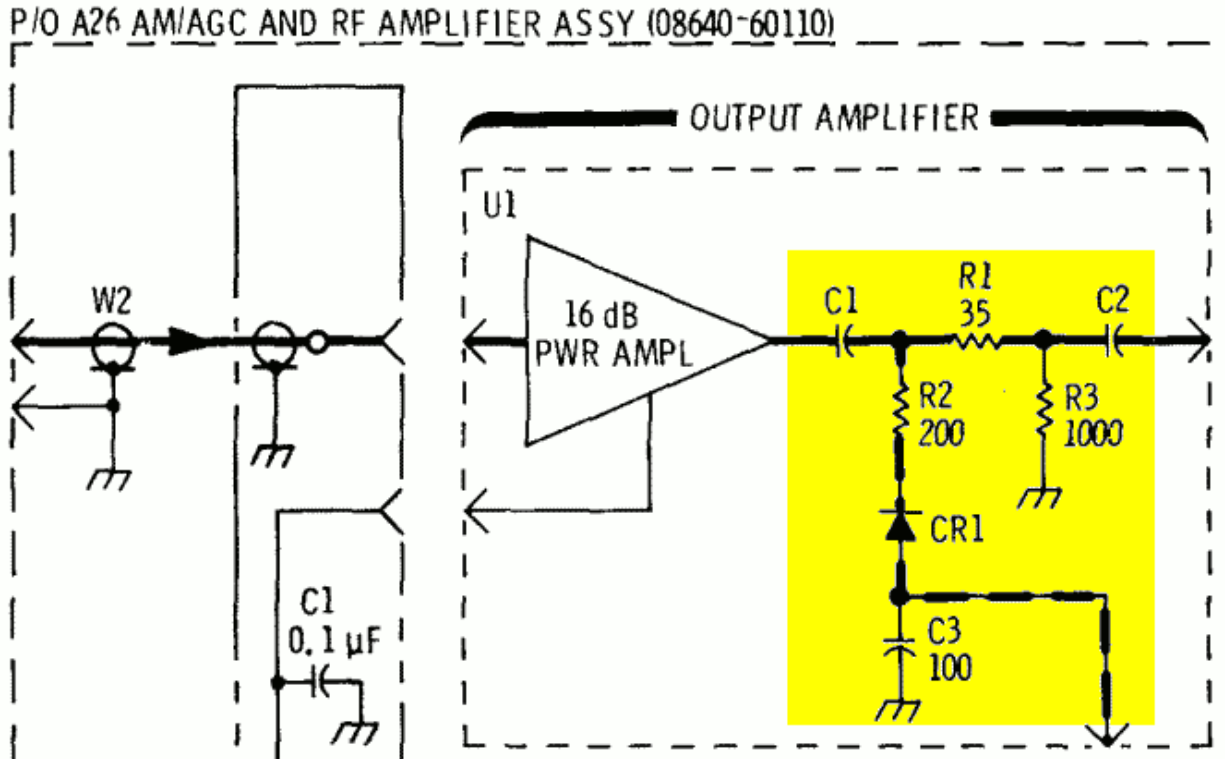
Apparently, my version (Option 1) uses a bias voltage from the hybrid amplifier to control the output signal level, where the above link was designed for the avionics version (Option 4), which does not. I could see on the schematic, (provided by one of the best sites around for older equipment manuals), that the hybrid contained a small RF detector circuit.
