HP 9153/54 A/B Service Manual

Manual part number: 5958-4122
Microfiche part no. 5958-4125

Printed: MAY 1988
Printed in U.S.A.

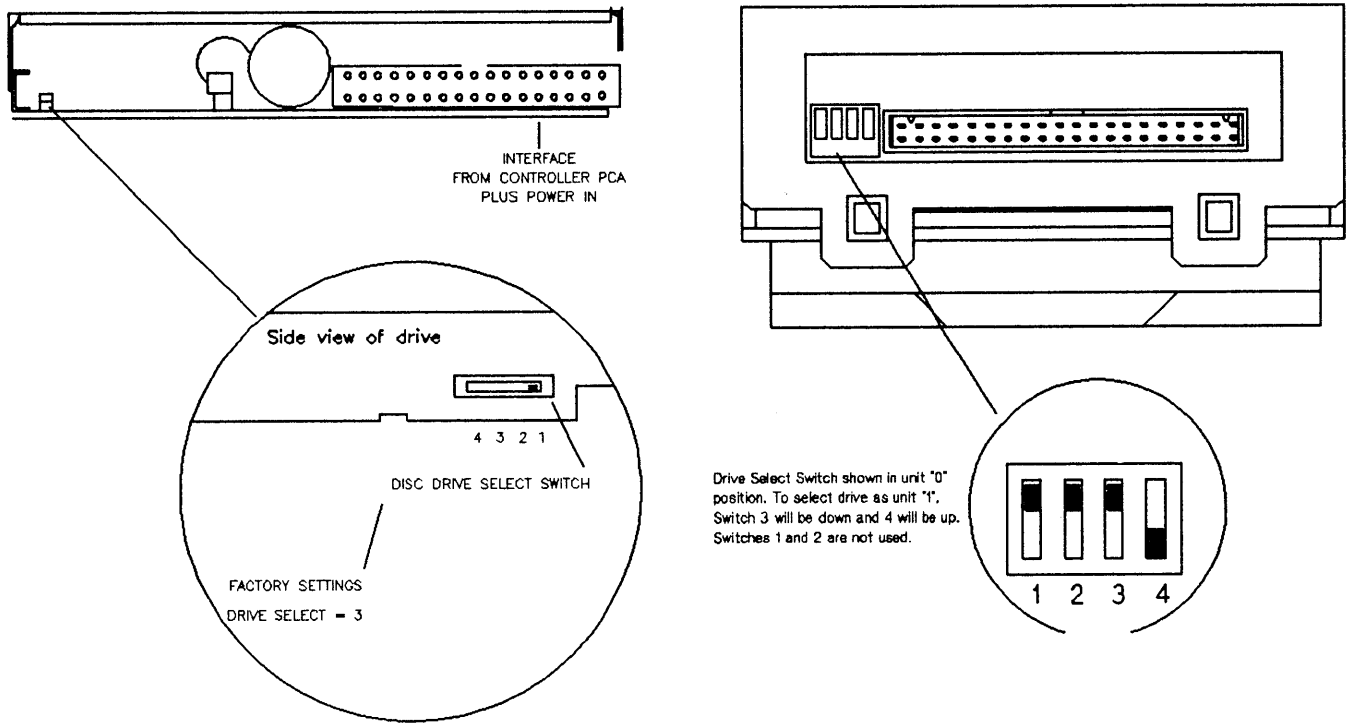
Figure 6-8. HP 9153A/HP 9154A drive configuration (S/N Prefix 2702A and above).

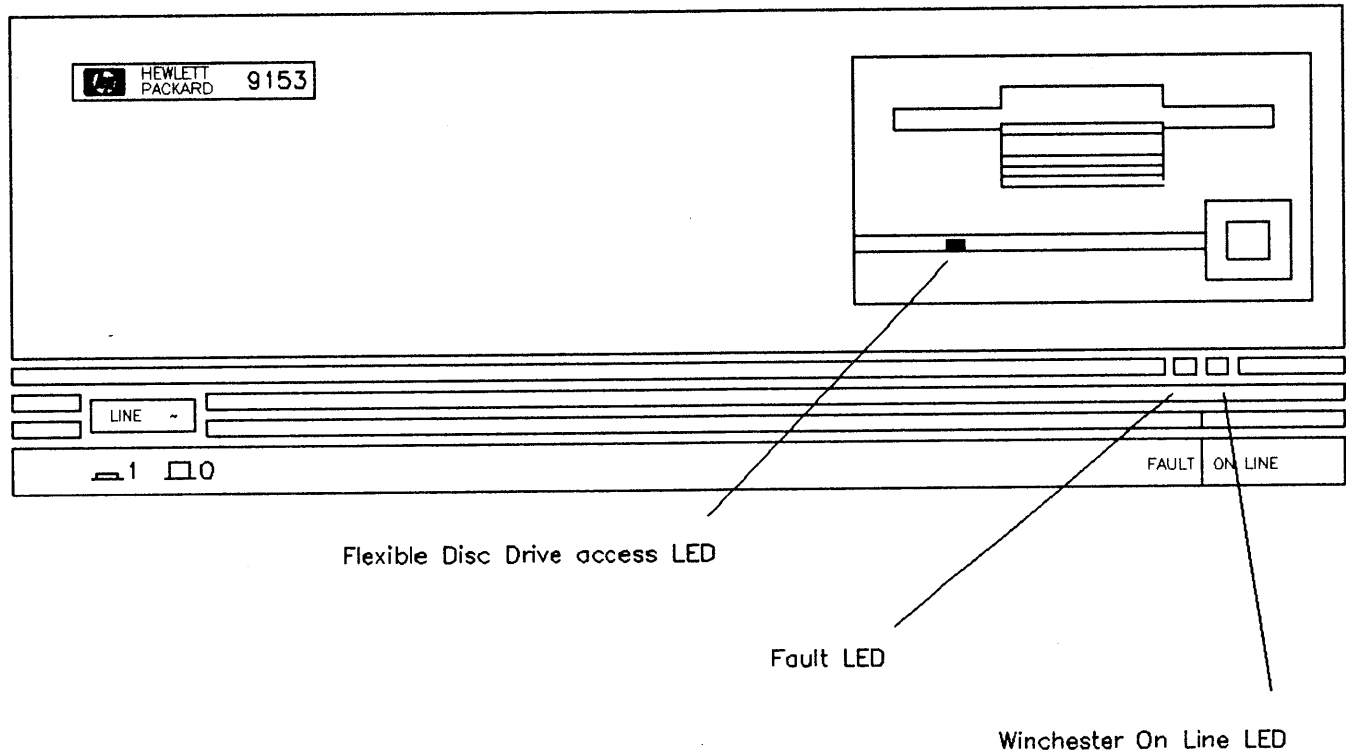
Figure 8-2. Front panel Control Indicators.

Refer to Figure 8-2 for location of LEDs mentioned in the following text.
